**LASER AND ELECTROCHEMICAL STUDIES OF METALLIZATIONS**  
**IN ELECTRONIC DEVICES**

Second Annual Research Report

J. Zahavi

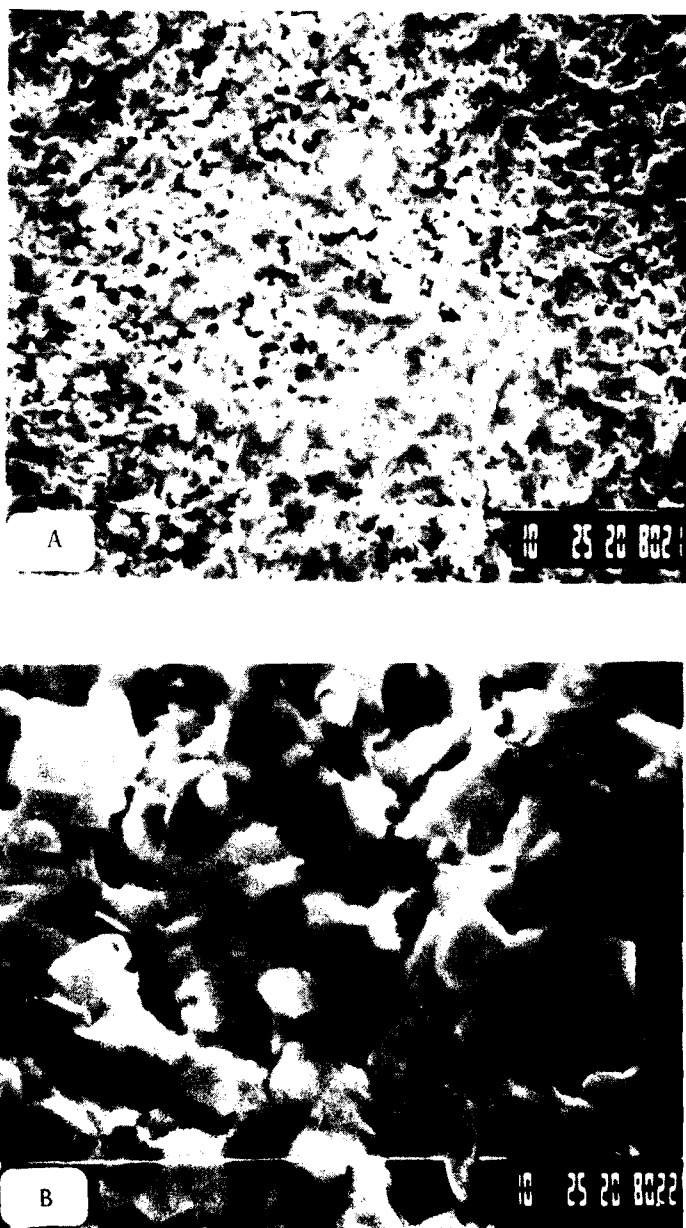
Fig. 3.24 SEM observation of corroded Pb-Sn laser treated specimen after polarization in  $10^{-2}$ M NaCl.

A. Corroded area x 100.

B. Corroded area x 7500.

The same corrosion mode was observed also for the coating thickness of  $12.7\mu\text{m}$  (Figs. 3.23, 3.24). The "B" micrographs show distinctly the boundary of the corroded area as only Sn crystals remain on the copper base.
